# Manhole Inspection Summary

Manhole # S37E\_\_041MH

Insp Date: **7/20/09 10:48 AM**

**Location** Address: **601 E. Fayette St**

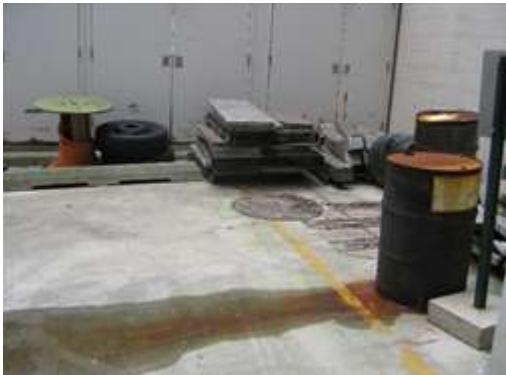
Location View

Comments **Located at Police Precinct; Fframe and cover too big for MH. Deep slope in channel, the reason for the huge difference in inverts.**
